9th International Conference „Bridges in Danube Basin 2016“, BDB 2016

Four historical steel bridges over the Mureş River

Abstract

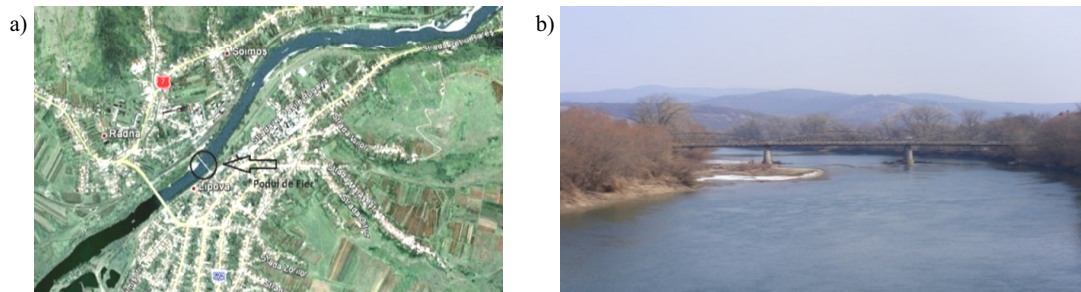
Fig. 6. (a) Pod Lipova – emplacement plan; (b) “the Iron Bridge” – Lipova – general view.

Due to the complete lack of maintenance, the bridge has many defects:

The city of Lipova has no documentation regarding the structure.

- completely removing of the pavement;
- sand blasting;
- necessary repairs – on the base of a project;
- new function: touristic info point, happenings spot. The bridge connects two main objectives (the old fortress -in rehabilitation- and the Franciscan Monastery - also in rehabilitation), with the old city center;
- painting of the structure;

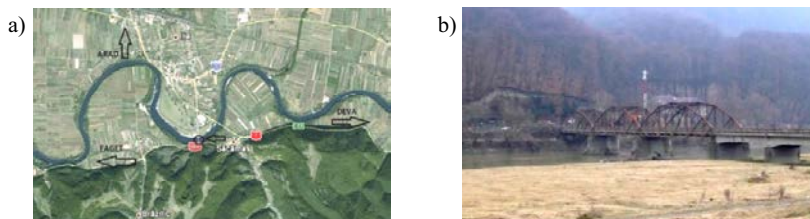
Fig. 9. The Bridge in Ilia: (a) emplacement plan; (b) general view.

More or less, this bridge features the same defects as the “Iron Bridge” in Lipova. As it is mentioned above, the bridge is being used without any limitations. Therefore there are some side effects such as the strong vibrations amplified also by the growth of the dynamic effect due to the damaged deck (Fig. 12a).
